Expert Report

Wadsworth v. Jetson et al

Derek King, M.S., P.E.

Berkeley Engineering and Research, Inc.
July 12, 2024

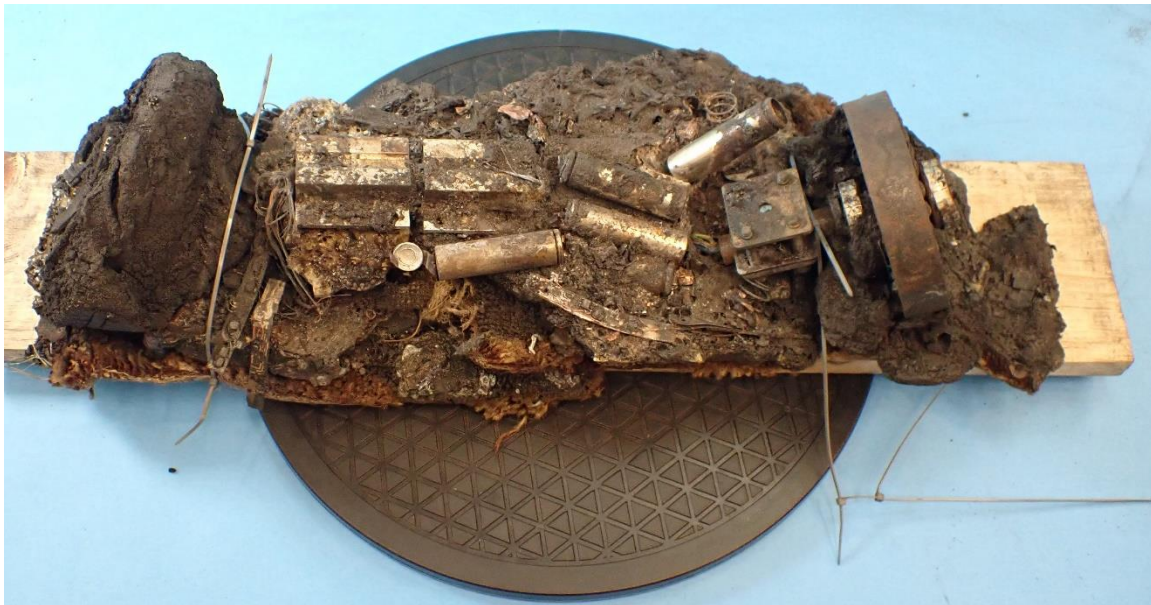
Figure 1: The remnants of the subject Jetson hoverboard.

Detailed examination of the subject board shows that two out of ten cells exploded while the other eight cells show heat damage. Exploding cells are consistent with an internal short, thermal runaway, and vaporization and ignition of the liquid electrolyte.

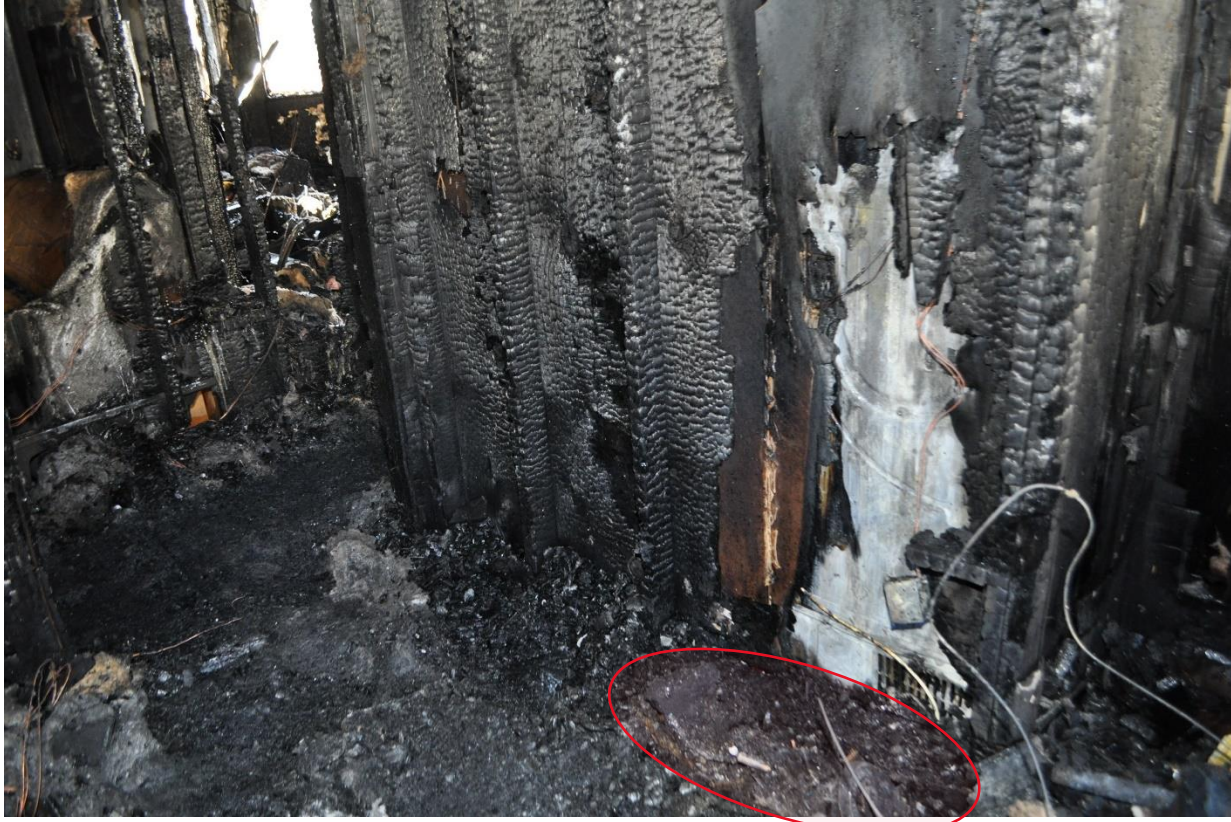
Figure 4: The general location of where the wall V-pattern points. The wall above the subject board (circled) is completely burned away.

- An exterior fire would have to rise along the wall, enter through the eaves, and then burn down to eventually reach the subject board. The exterior wall should therefore be exposed to the fire for the longest duration.
- The exterior of the house at and around the window area is substantially less fire damaged than the interior. The exterior wall studs are largely intact. This suggests a shorter and less intense exposure to fire on the outer wall compared to the interior.
- Detective Sheaman observed an interior V-pattern which included studs which were nearly completely consumed by the fire.

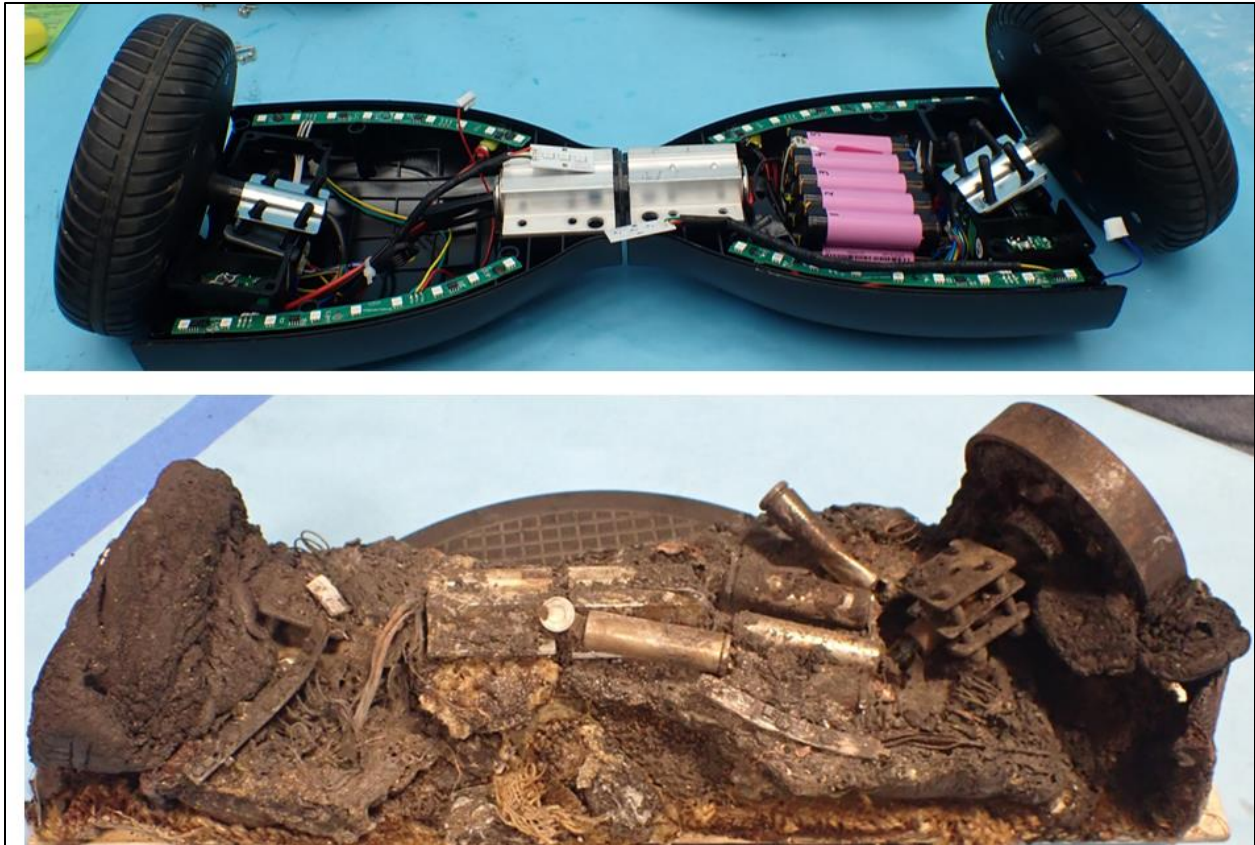
The evidence was compared with a disassembled exemplar. The combination of visual and CT scan data allowed the identification of the subject cells' original orientation.

Figure 6: An exemplar board disassembled and oriented approximately the same as the evidence.
